STUDY OF EMBANKMENT PERFORMANCE DURING OVERTOPPING AND THROUGHFLOW

Report 3

MODEL-PROTOTYPE COMPARISON STUDIES

Hon-Yim Ko, R. Jeffrey Dunn, Tom Hollingsworth

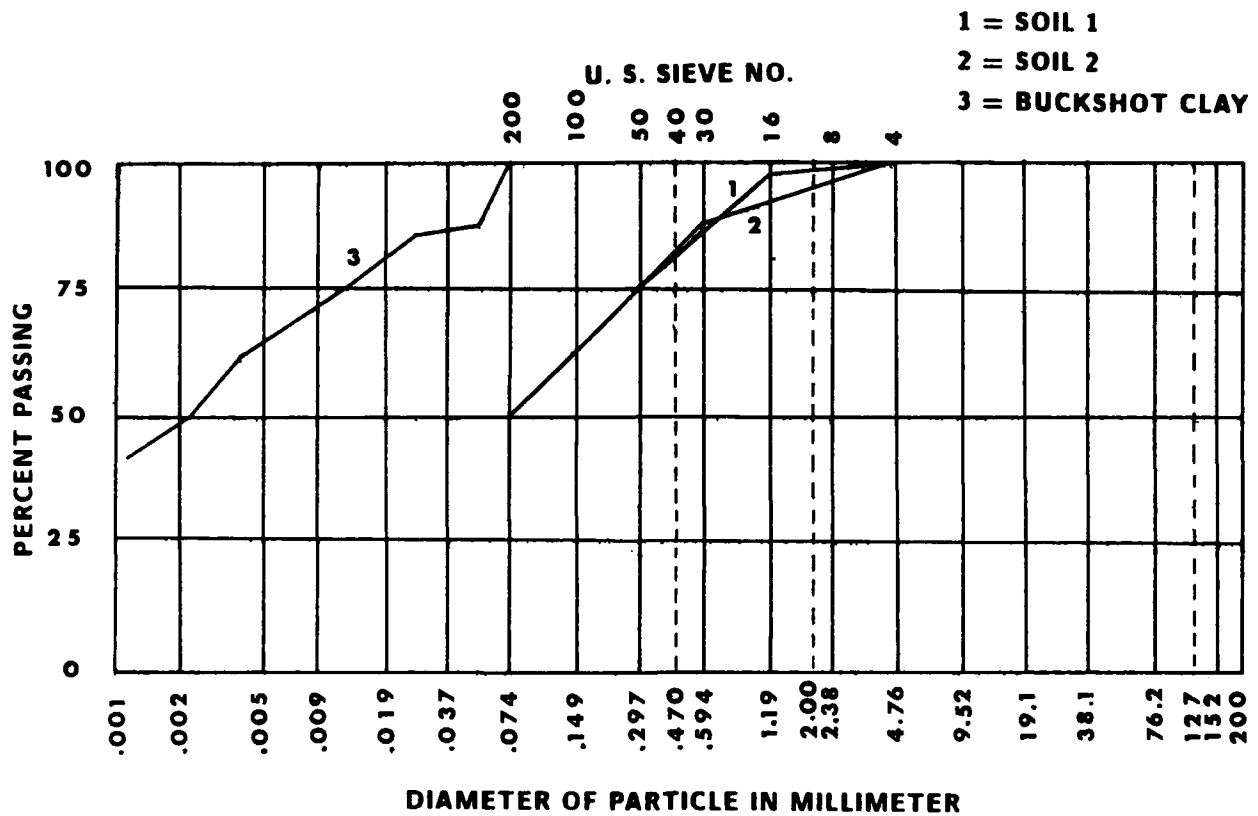
Figure 1 Grain size distribution Curves.

(7) The fine material in Soil 2 consisted of buckshot clay provided by WES. The buckshot clay was found to have a liquid limit of 64, a plastic limit of 22 and a plasticity index of 42. Hydrometer analysis results, as presented in Figure 1, show that buckshot clay is 100% finer than the #200 sieve. To meet the criteria, 50% coarse material by weight was added in equal portions on the #30, #50 and #100 sieves. Soil 2 was composed of 50% buckshot clay and 50% coarse material by weight. The grain size curves for Soil 1 and Soil 2 are also shown in Figure 1. Standard Proctor compaction tests were run on Soil 1 and Soil 2 to obtain the moisture-density relationships which are presented in Figures 2 and 3.

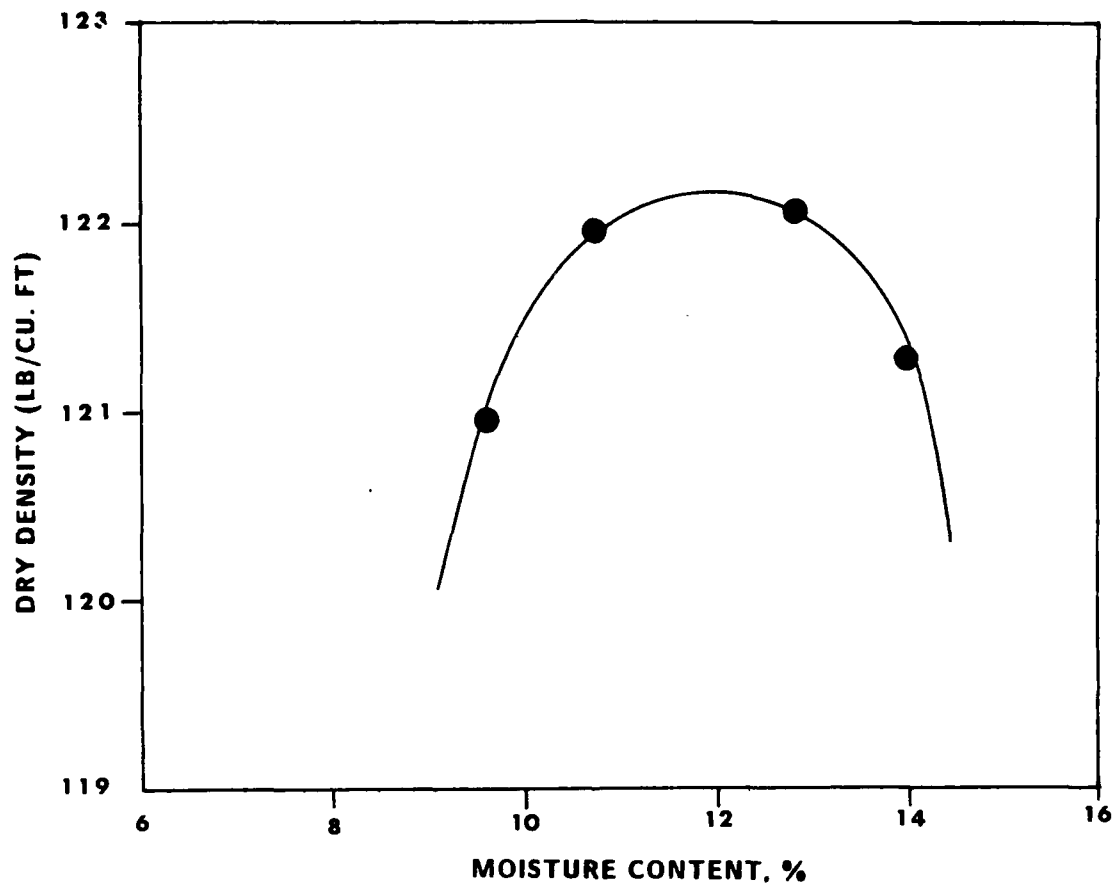
Figure 2 Moisture - density relationship for soil 1.

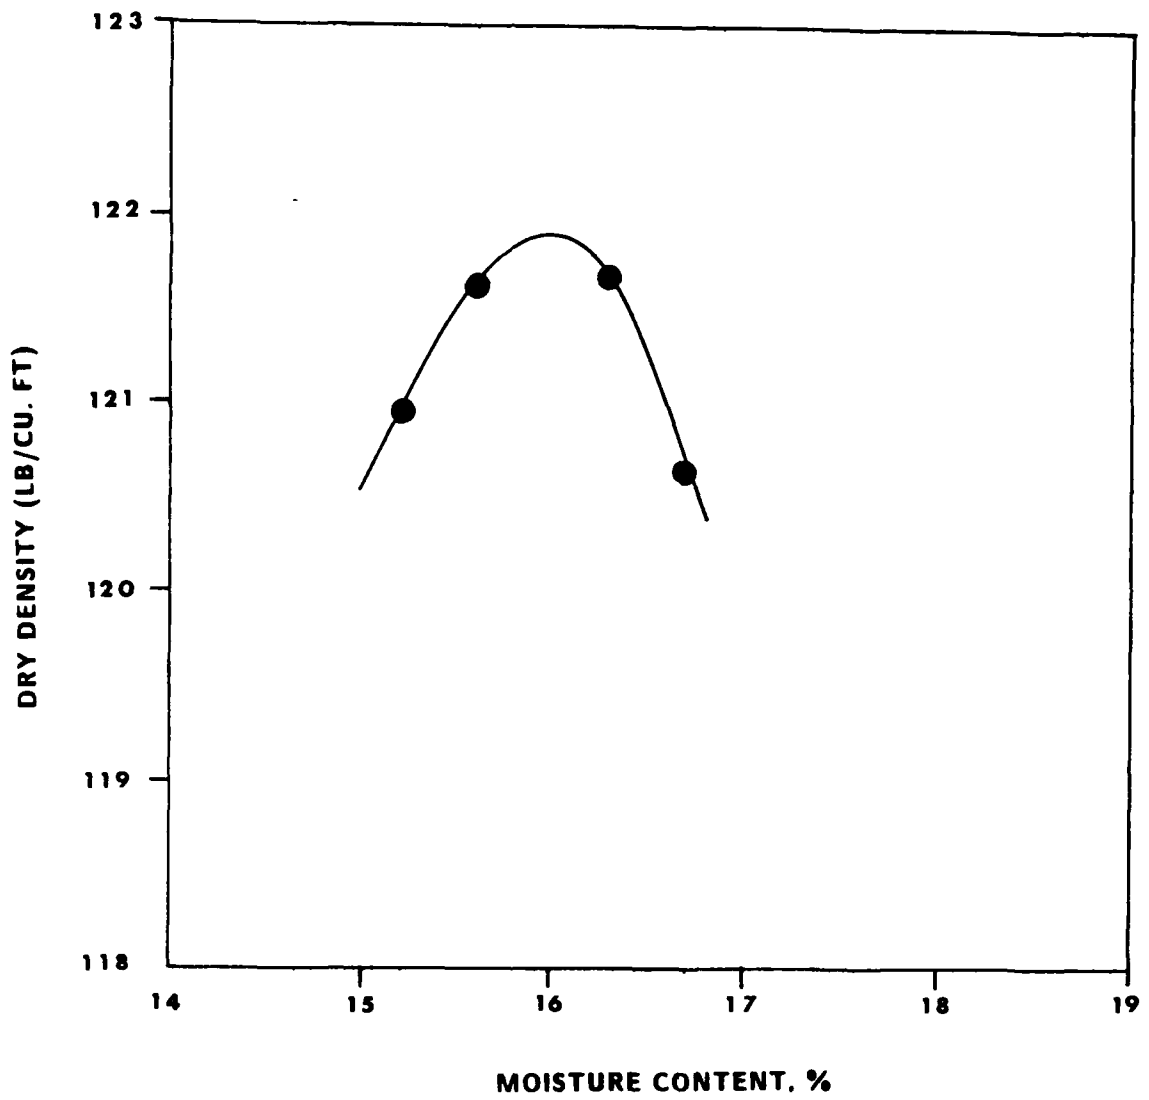
Figure 3 Moisture - density relationship for soil 2.

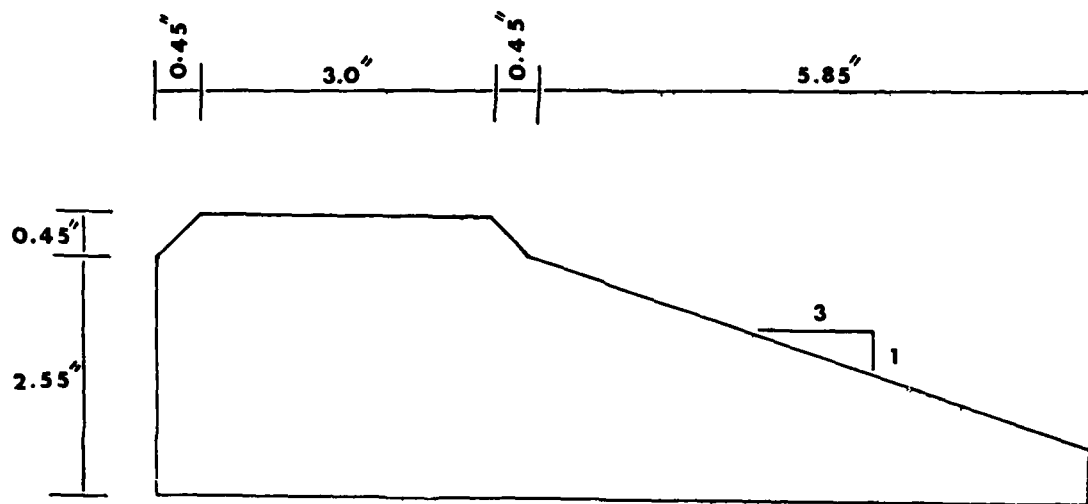
Figure 4 Configuration of Clarence Cannon Cofferdam.

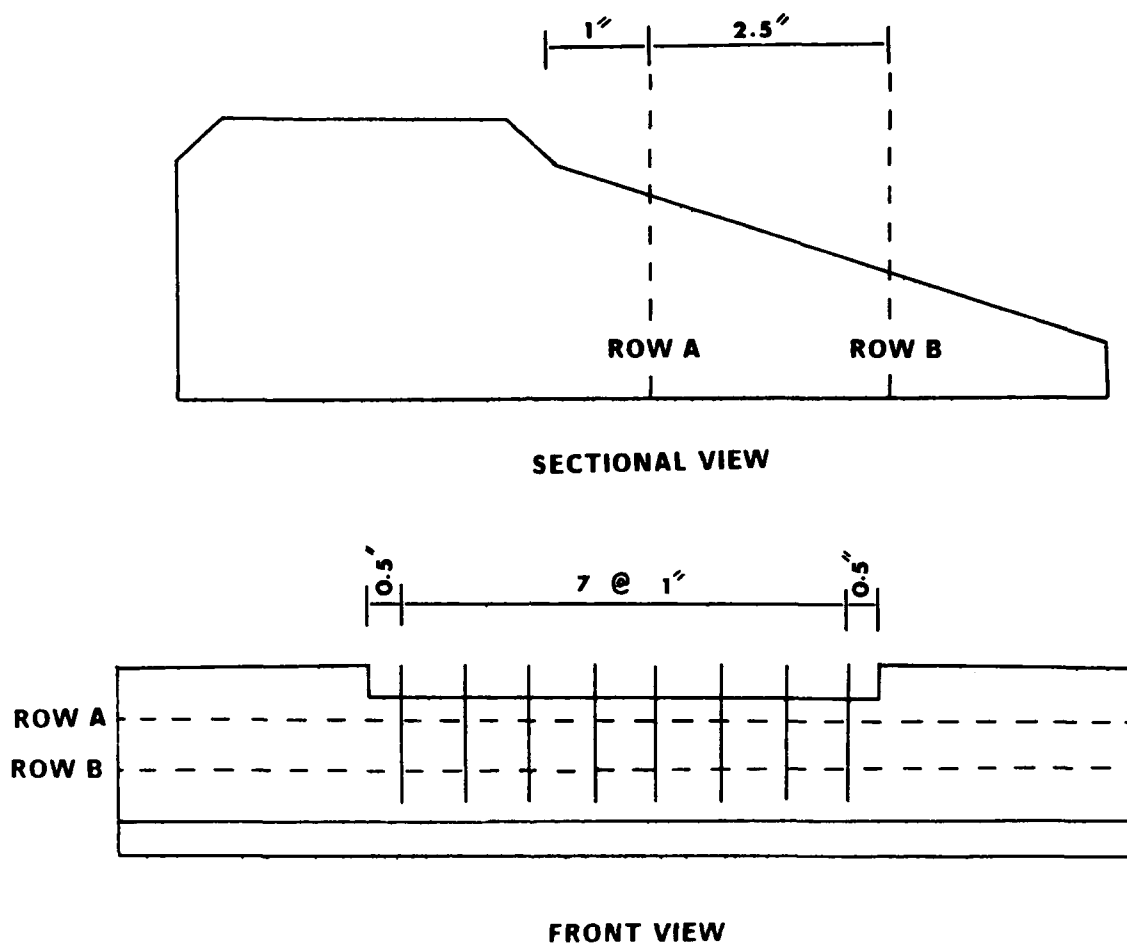
Figure 5 Manual measurement points for Clarence Cannon Cofferdam.

- [1] Initial manual measurements of the embankment profile at eight points across the embankment cross-sections shown on Figure 5 were made with a machinist's scale.
- [2] Initial photographs of the embankment were taken.
- [3] The centrifuge was accelerated to 270 r.p.m.
- [4] The video tape recorder was started to record the test.
- [5] The overtopping flow was then started and the increase in weight slowed the centrifuge to 250 r.p.m. or approximately 80g where it remained for the test period.
- [6] The depth of overtopping flow followed the following schedule:

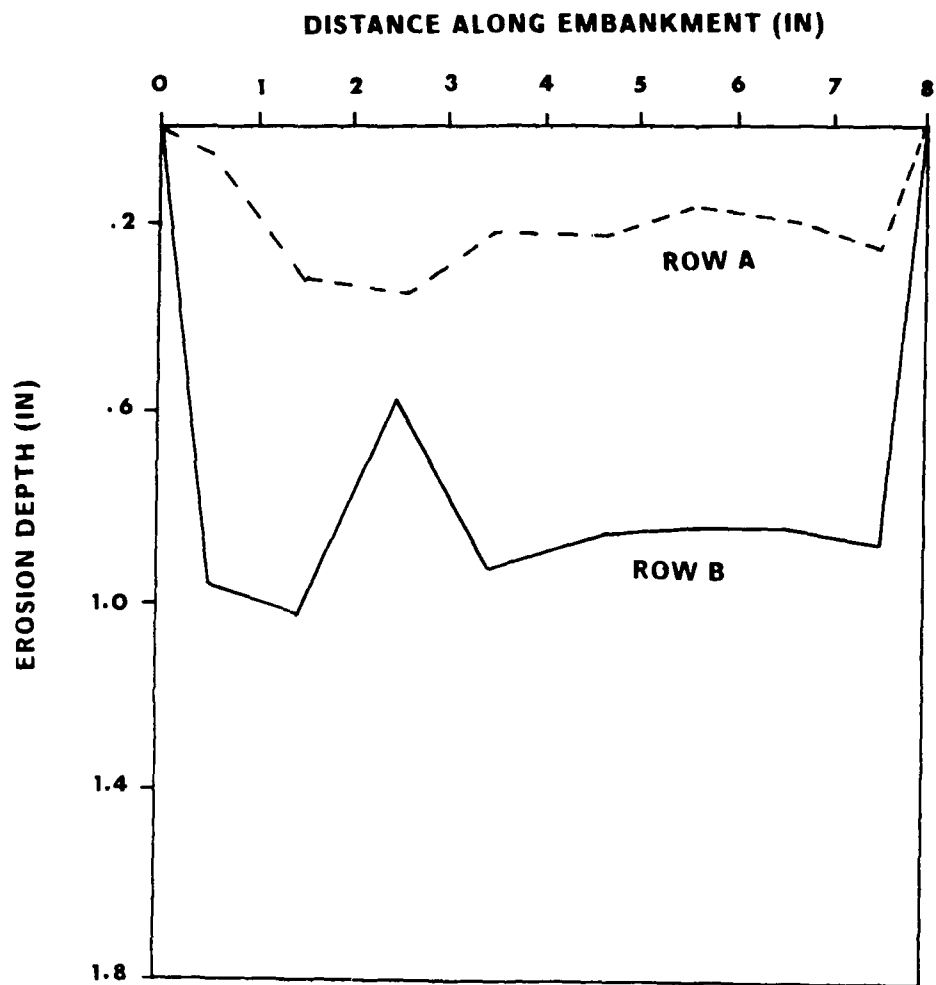
Figure 6 Erosion cross sections for Clarence Cannon Cofferdam. (soil 1, test 1).

(15) After the test was completed, erosion depth measurements were taken as described and the data plotted. The results for the two tests on Soil 1 are shown in Figures 6 and 7. The two tests on Soil 2 are shown in Figures 8 and 9. The volume of material eroded was calculated from the cross-sections in these figures. A plane planimeter was used to find the eroded area of the cross-sections and then the volume was found by averaging the areas and multiplying by the distance between the cross-sections. The data were presented as percent volume eroded which was calculated by dividing the eroded volume by the volume of material available, as defined in Figure 10. Figure 11 shows the test results for Soil 1 and Soil 2.

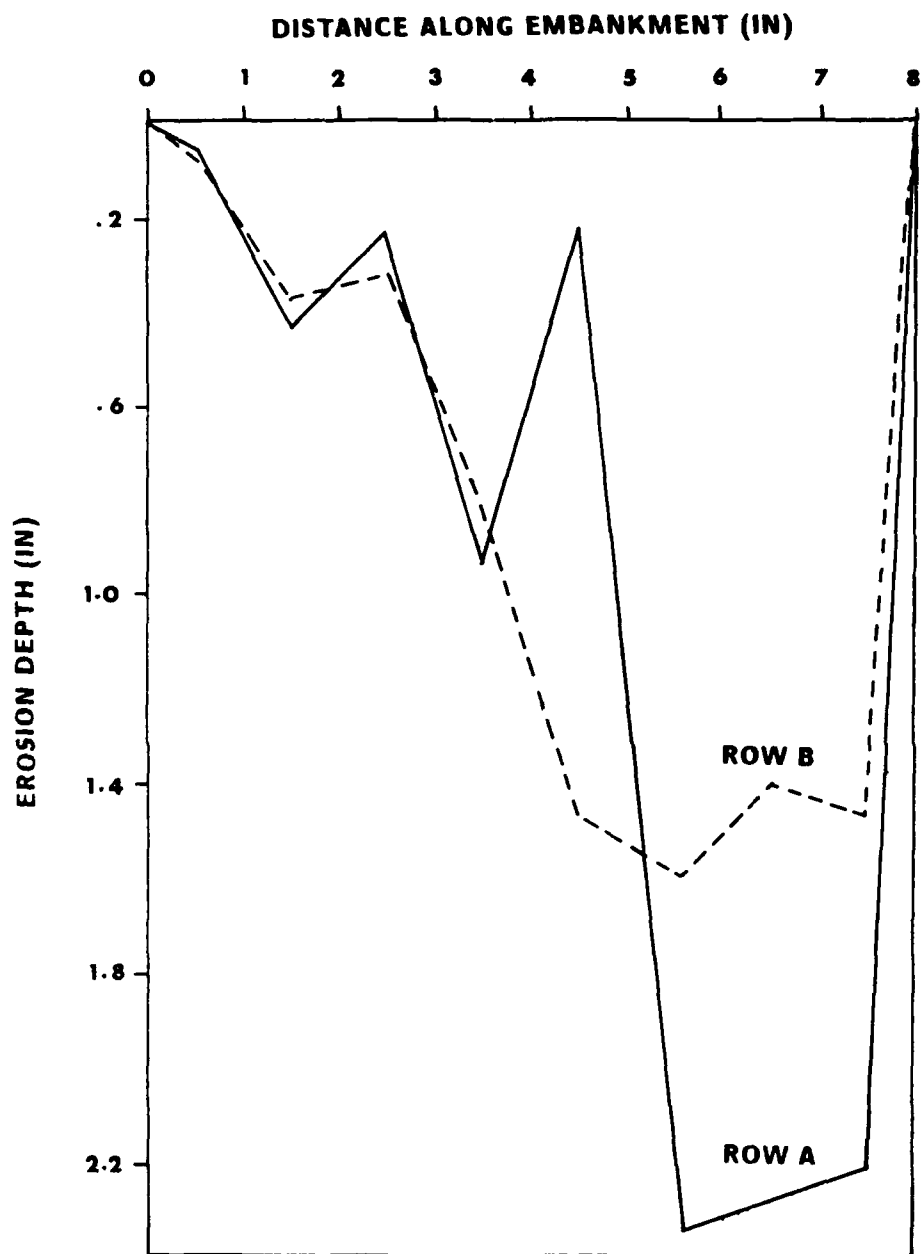
Figure 7 Erosion cross sections for Clarence Cannon Cofferdam. (soil 1, test 2).

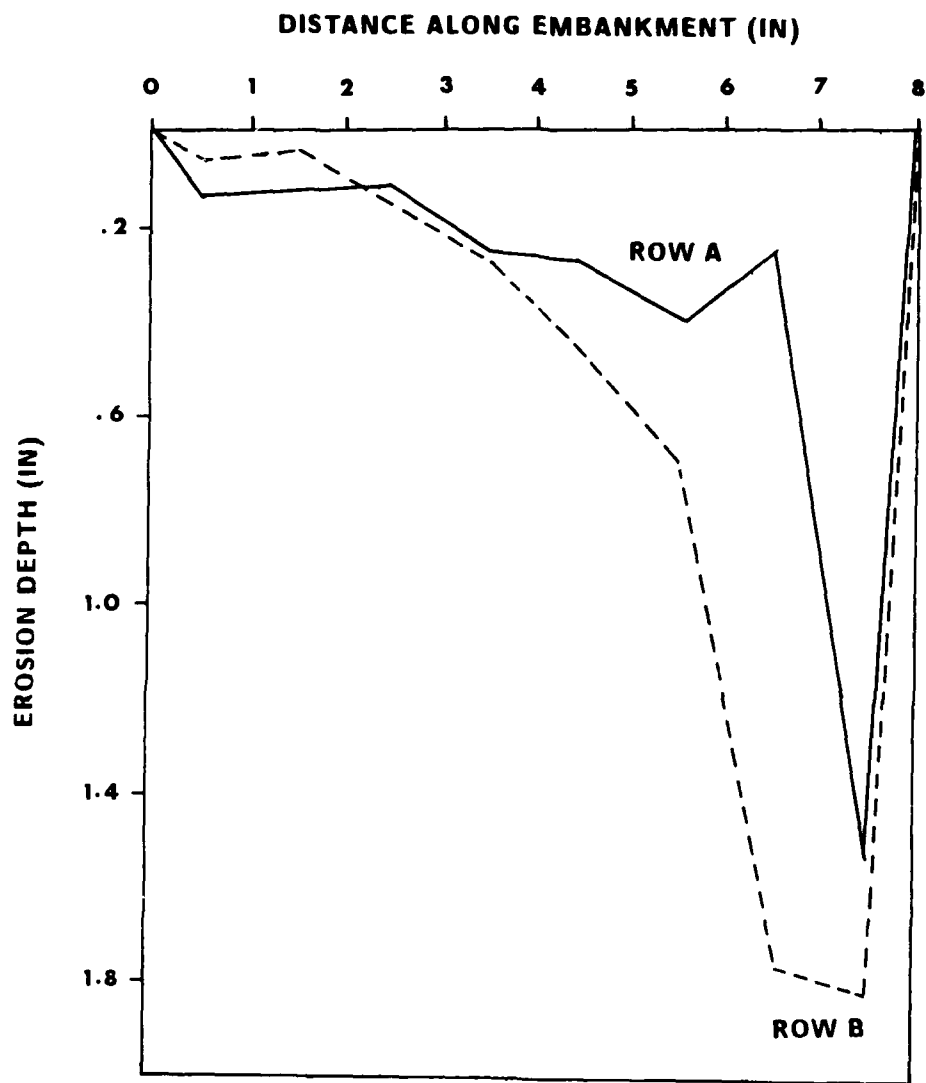
Figure 8 Erosion cross sections for Clarence Cannon Cofferdam. (soil 2, test 1).

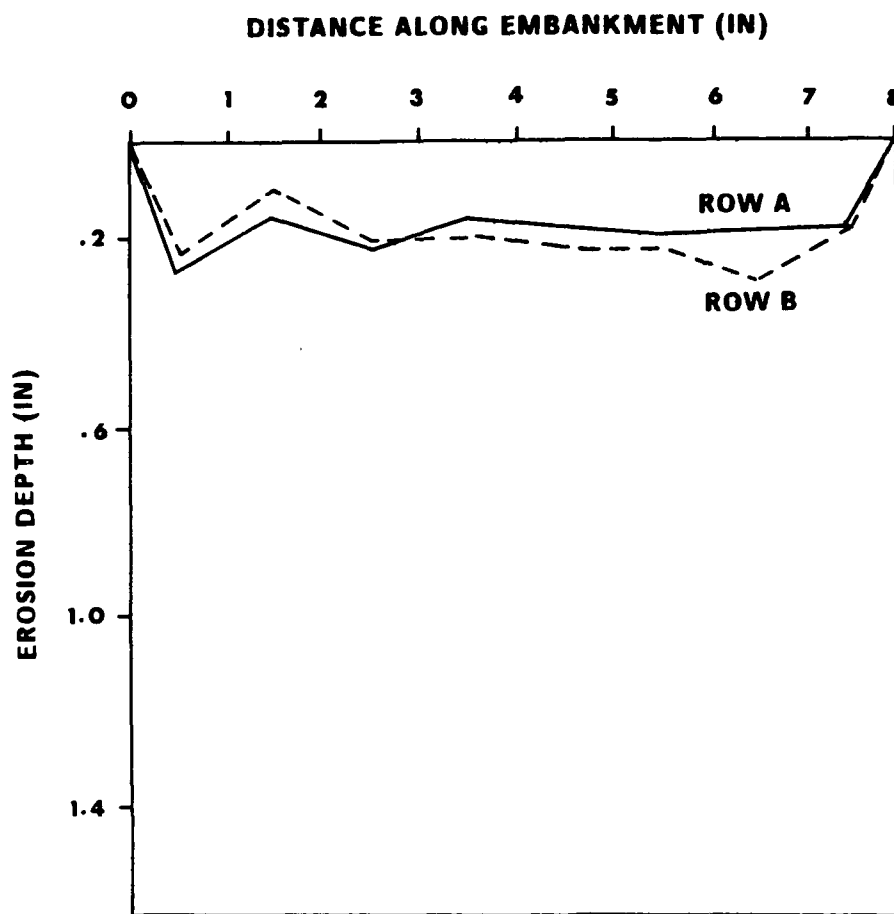
Figure 9 Erosion cross sections for Clarence Cannon Cofferdam. (soil 2, test 2).

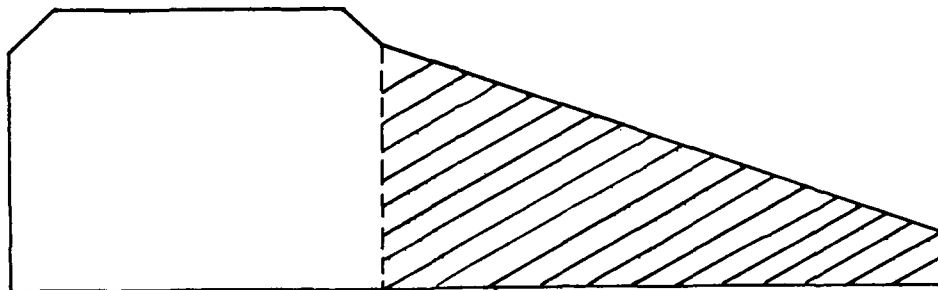
(VOLUME IS EQUAL TO SHADED AREA TIMES EMBANKMENT WIDTH)

Figure 10 Volume available for erosion Clarence Cannon Cofferdam.

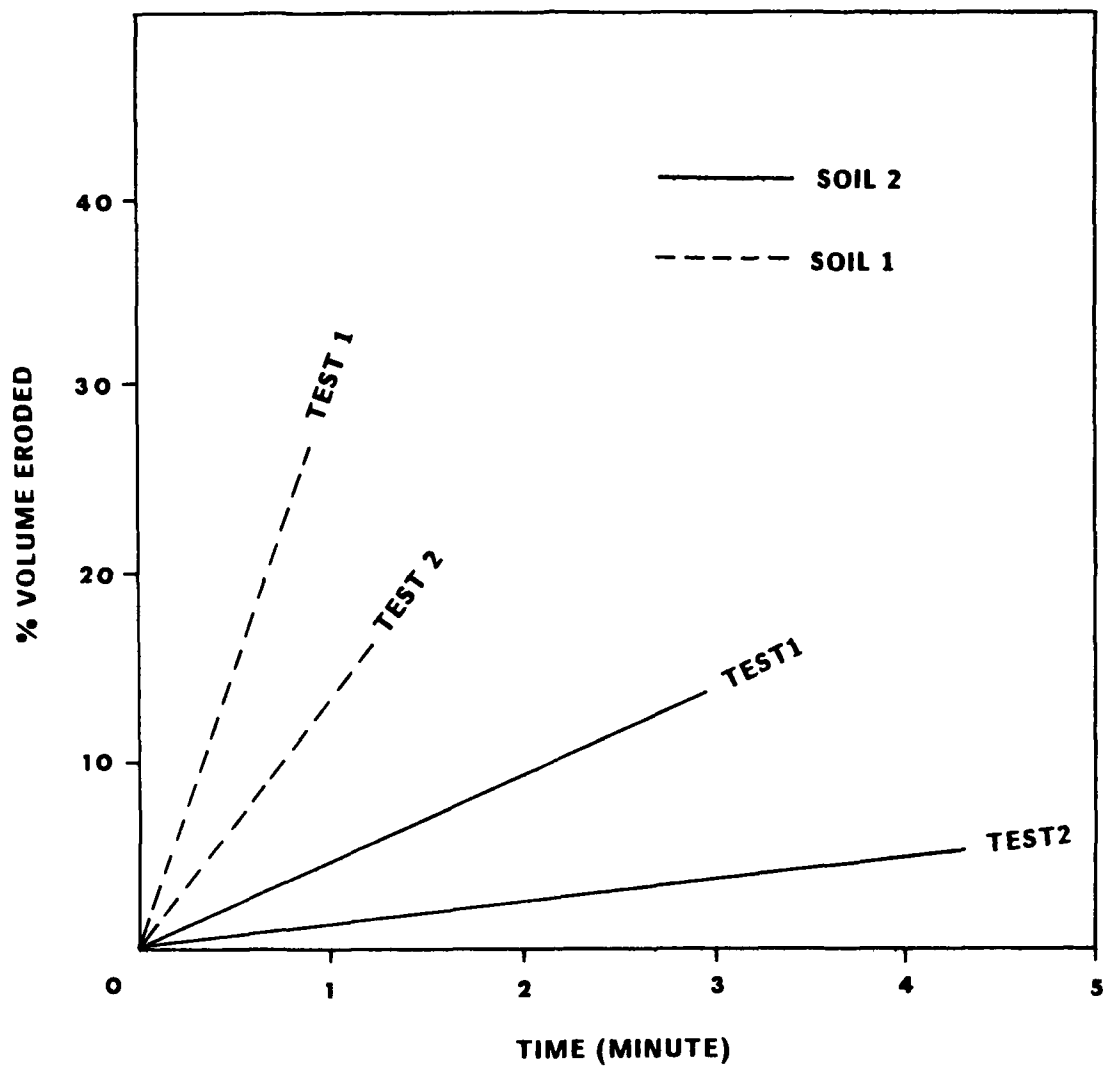
Figure 11 % Volume eroded vs. time for Clarence Cannon Cofferdam.

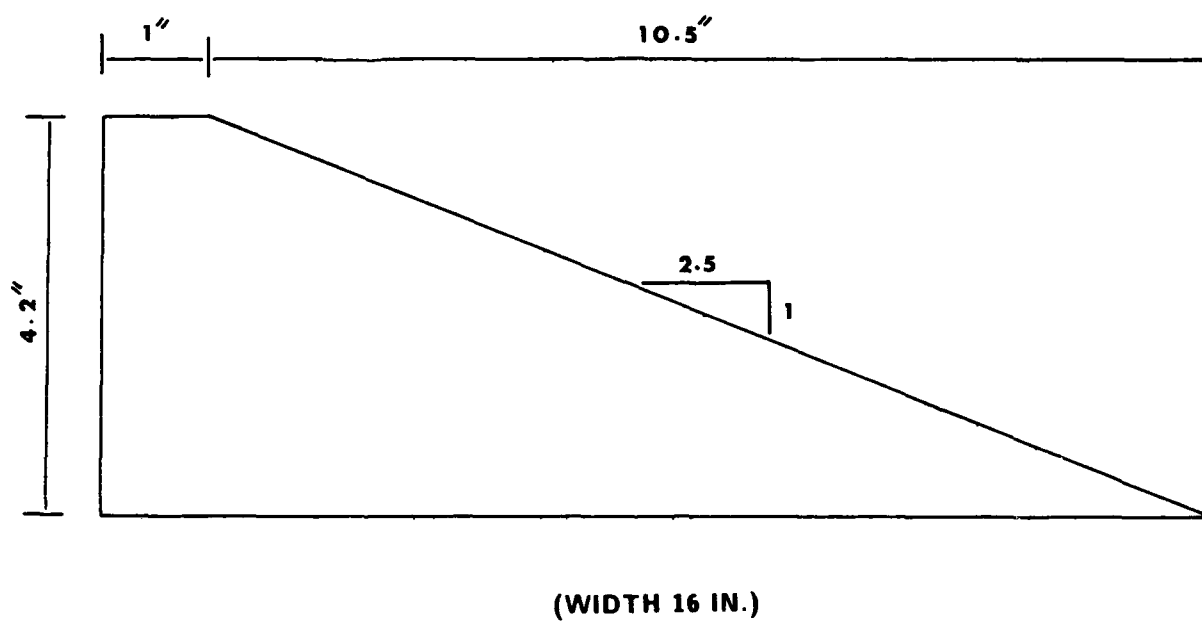
Figure 12 Configuration of Bloomington Lake Cofferdam.

(22) The preparation of the model of Bloomington Lake Cofferdam followed the same procedure as that used in modeling of Clarence Cannon Cofferdam. The rectangular block of soil that was compacted was trimmed to the configuration shown in Figure 12. A toe weir was not installed because a tailwater condition was not wanted.

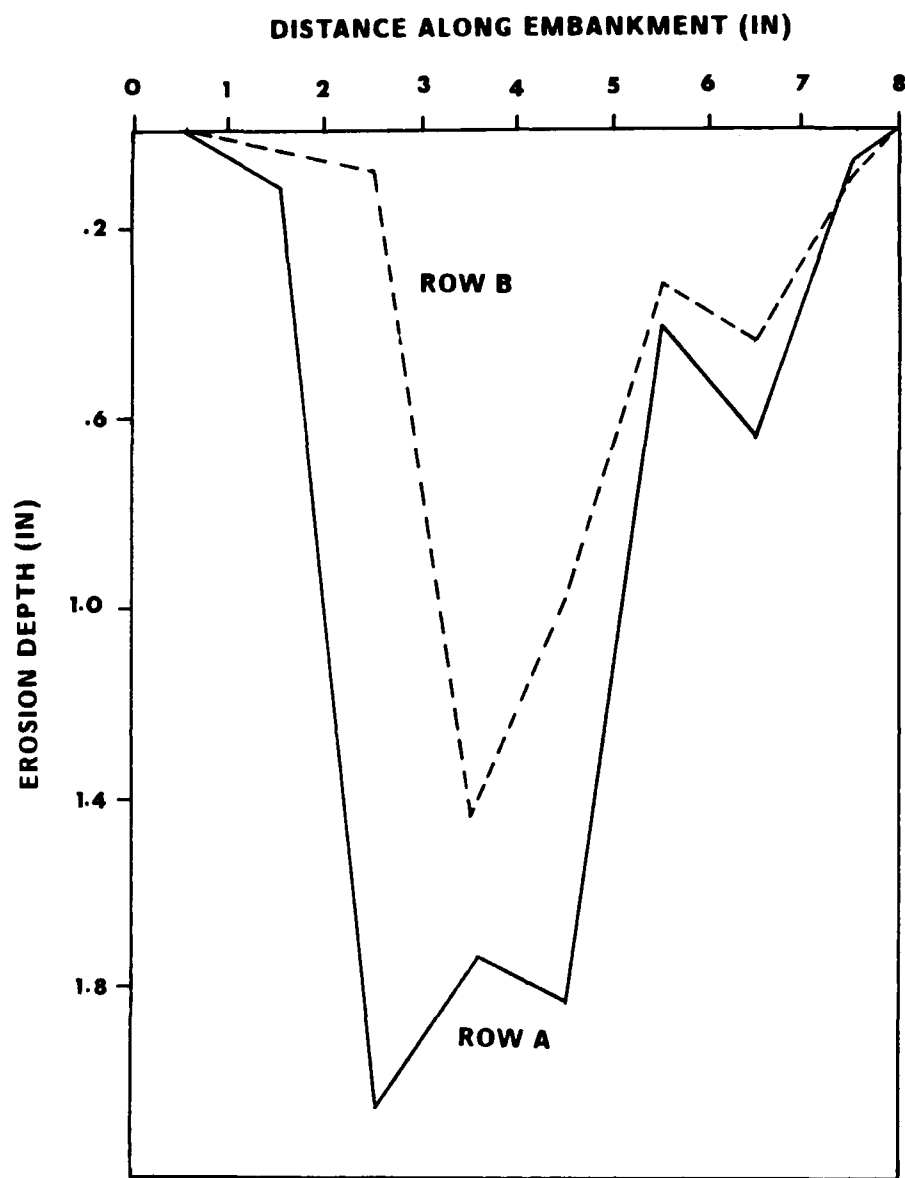
Figure 13 Erosion cross sections for Bloomington Lake Cofferdam.
(soil 1, test 1).

(25) Erosion depth measurements were taken as previously described and the data were plotted to produce the cross-sections in Figures 13, 14, 15 and 16. Figures 13 and 14 are from tests using Soil 1, and Figures 15 and 16 are from tests using Soils 2. The percent volume eroded was computed as described previously, and the results were plotted. Figure 17 shows the available volume for erosion. Figure 18 shows the results of tests using Soil 1 and Soil 2.

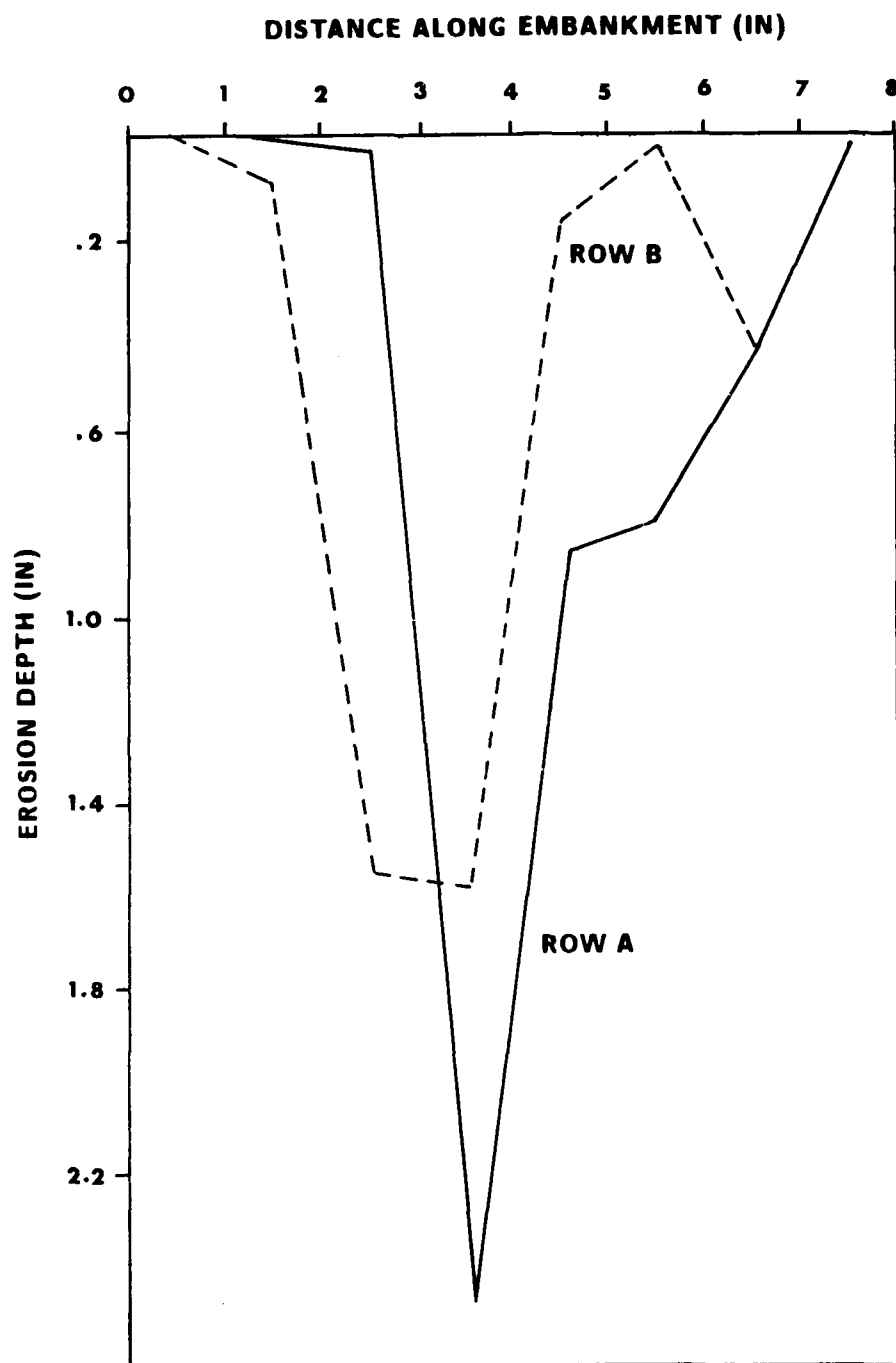
Figure 14 Erosion cross sections for Bloomington Lake Cofferdam.
(soil 1, test 2).

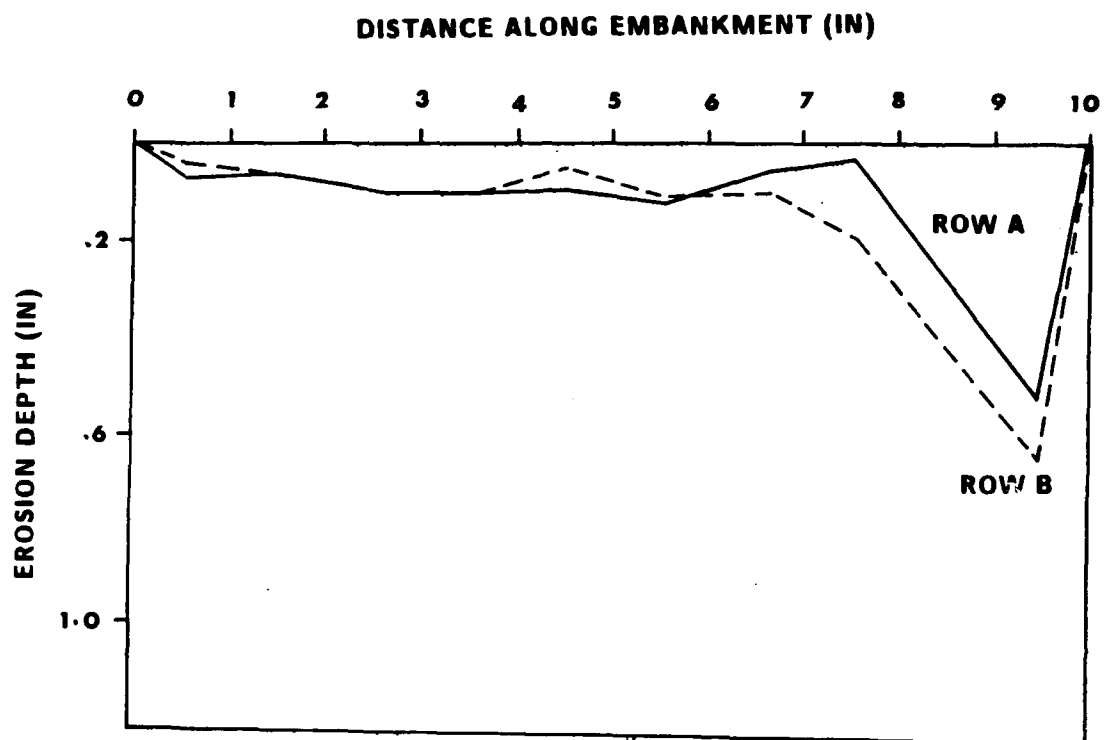
Figure 15 Erosion cross sections for Bloomington Lake Cofferdam.
(soil 2, test 1).

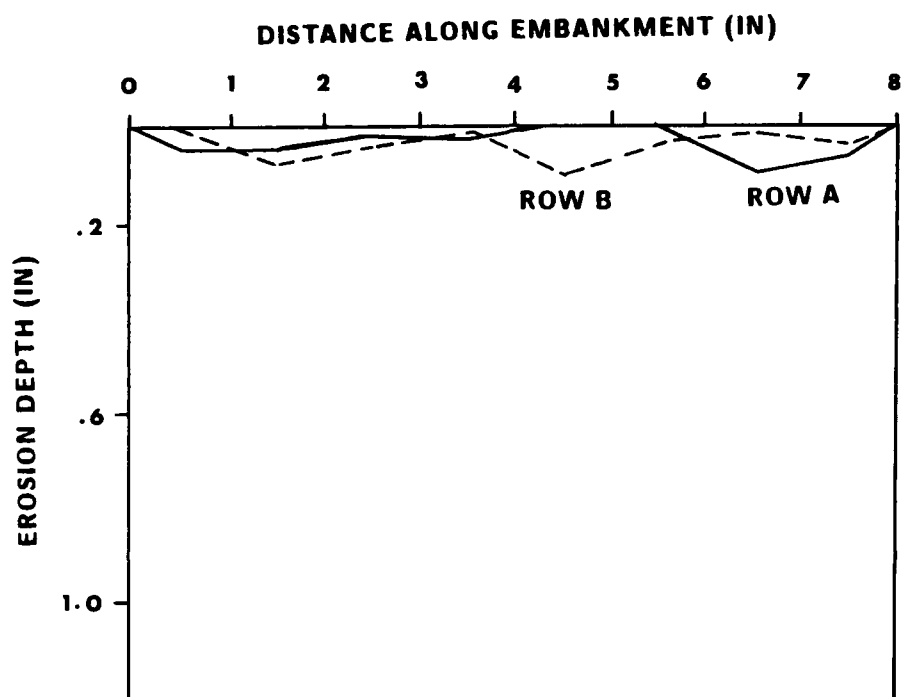
Figure 16 Erosion cross sections for Bloomington Lake Cofferdam.
(soil 2, test 2).

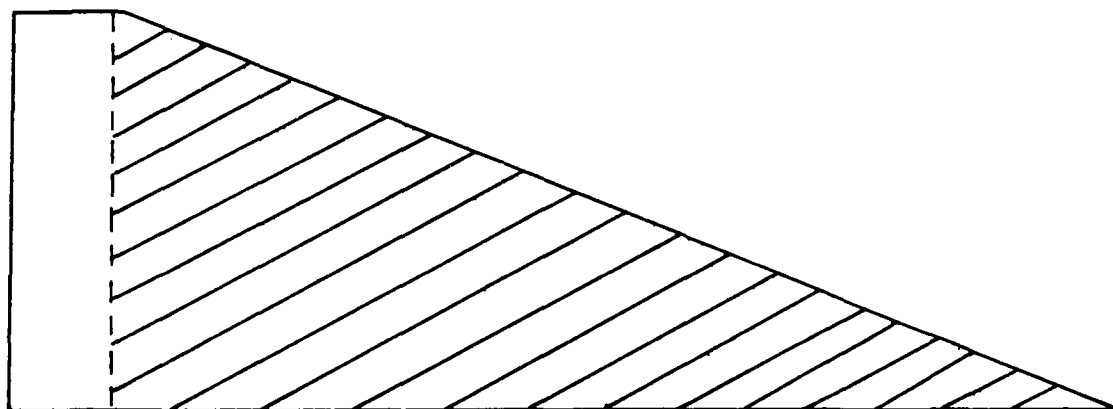
(VOLUME IS EQUAL TO SHADED AREA TIMES EMBANKMENT WIDTH)

Figure 17 Available volume for erosion for Bloomington Lake Cofferdam.

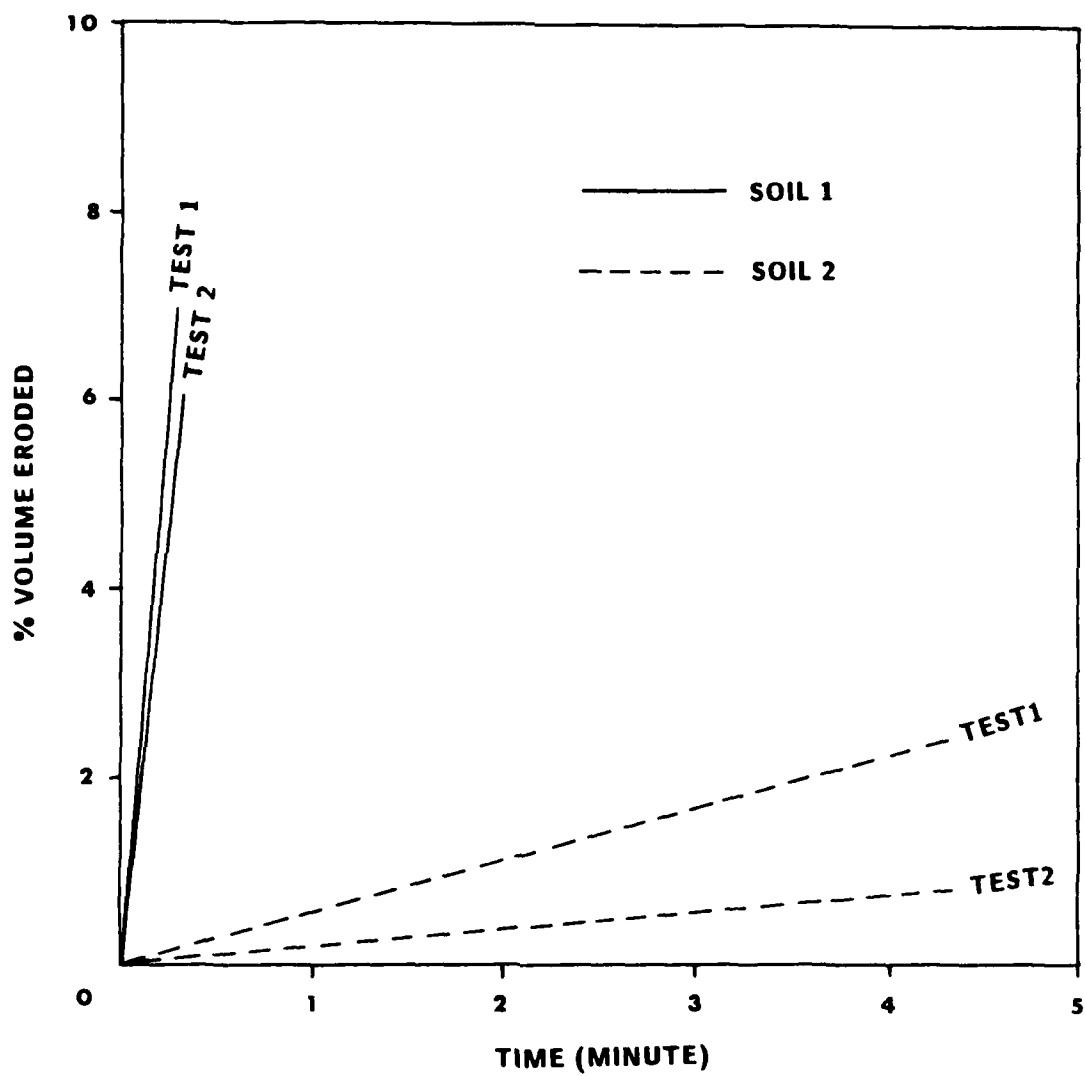
Figure 18 % Volume eroded versus time of Bloomington Lake Cofferdam.

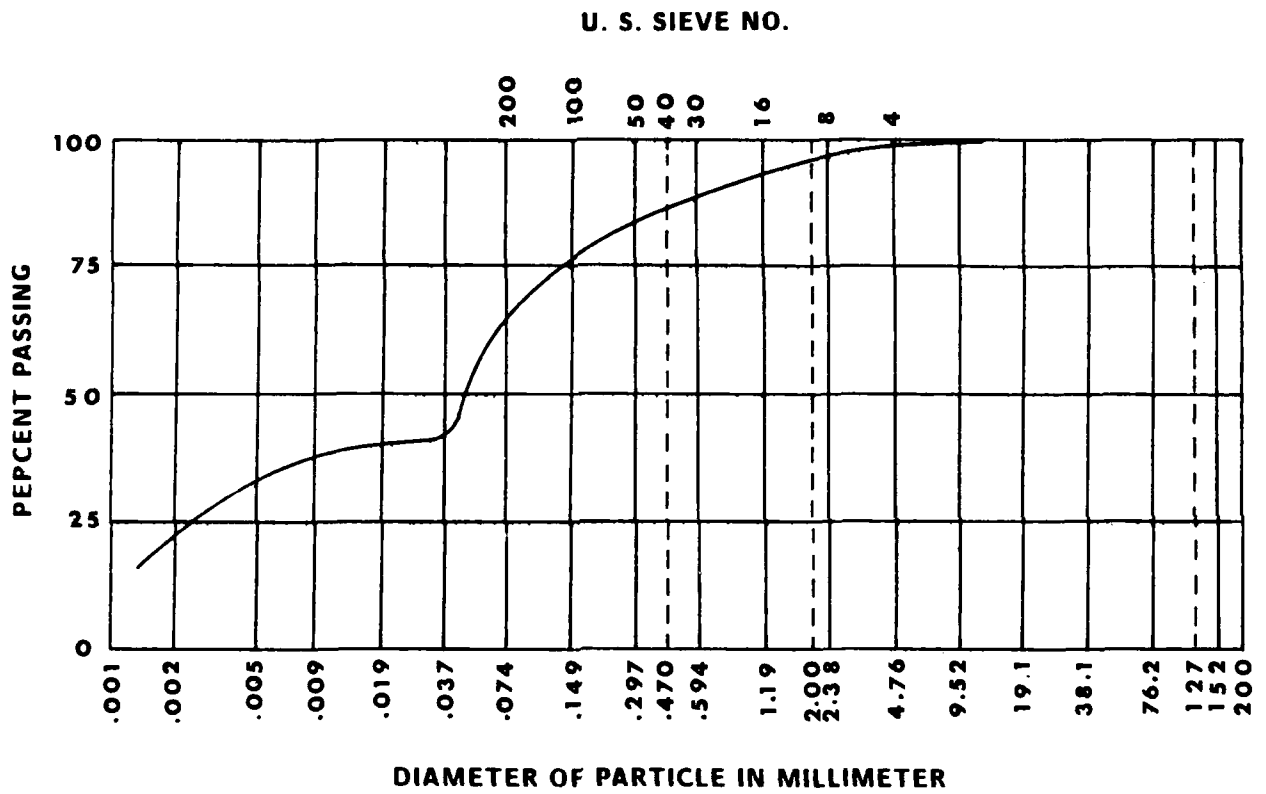
Figure 19 Grain size analysis for Simon, Li and Associates Soil.

(28) The soil used in the modeling was provided by Simons, Li & Associates (SLA) and came from their test embankment located at the research facility on the Colorado State University campus. The soil was the same sandy clay soil used by Ko, et al., in Reference [2]. The Atterberg limits were determined to be: liquid limit of 39, plastic limit of 26 and plasticity index of 13. The gradation analysis and standard Proctor compaction results are shown in Figures 19 and 20.

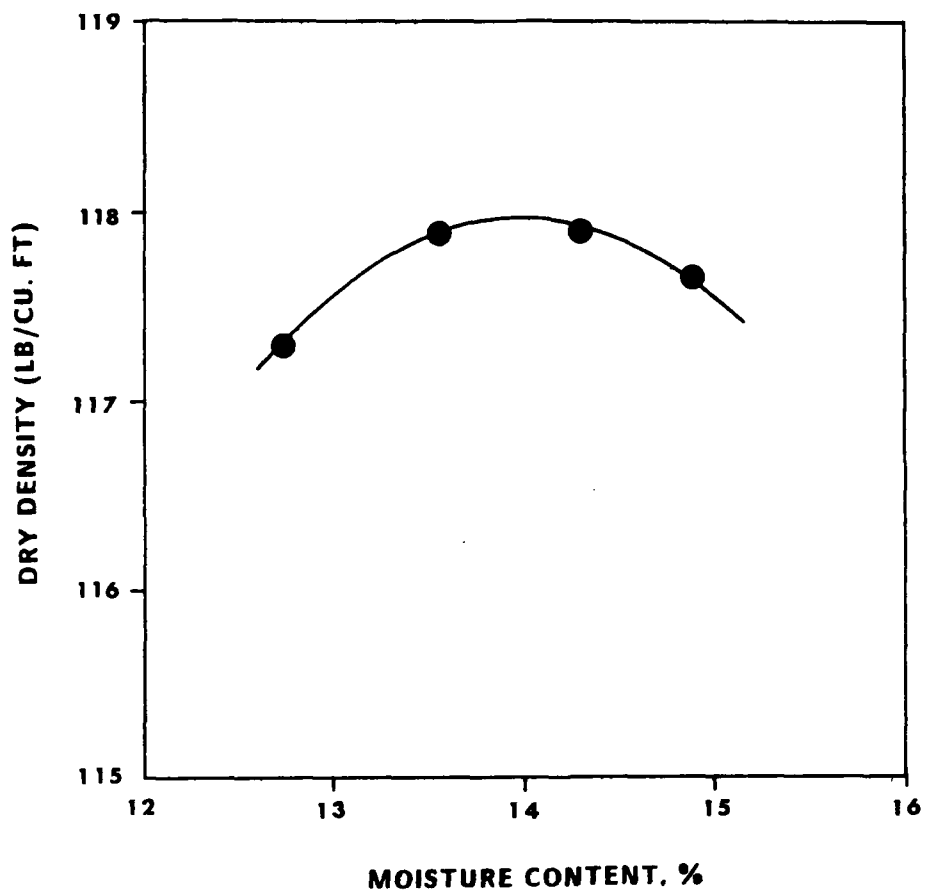
Figure 20 Moisture - density relationships for Simon, Li and Associates Soil.

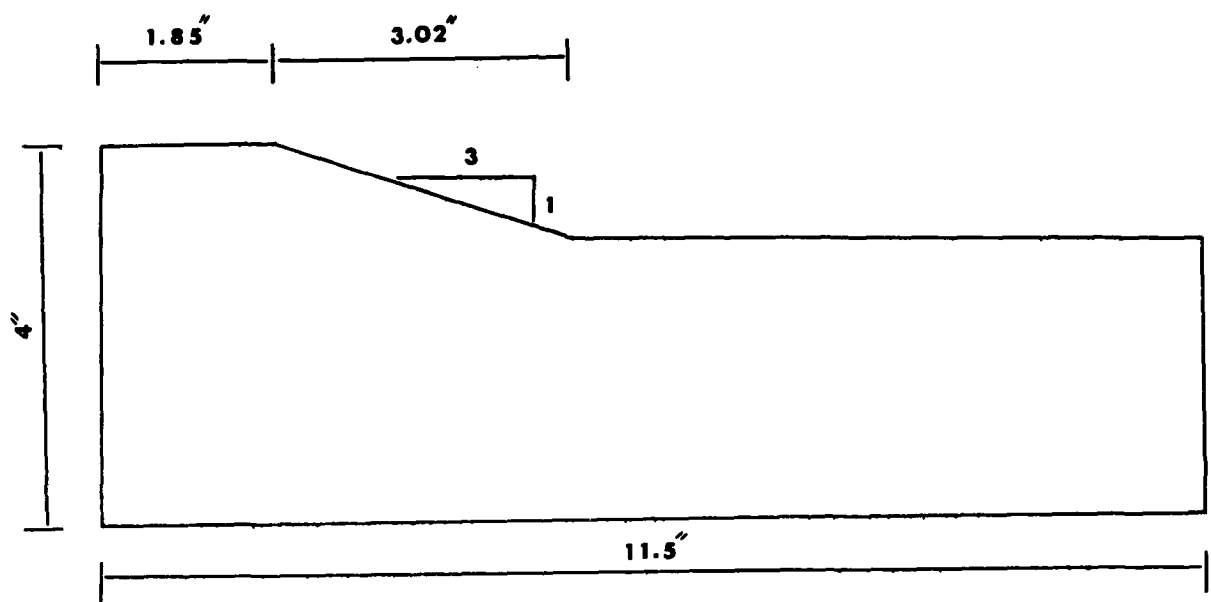
Figure 21 Configuration of the model of SLA embankment.

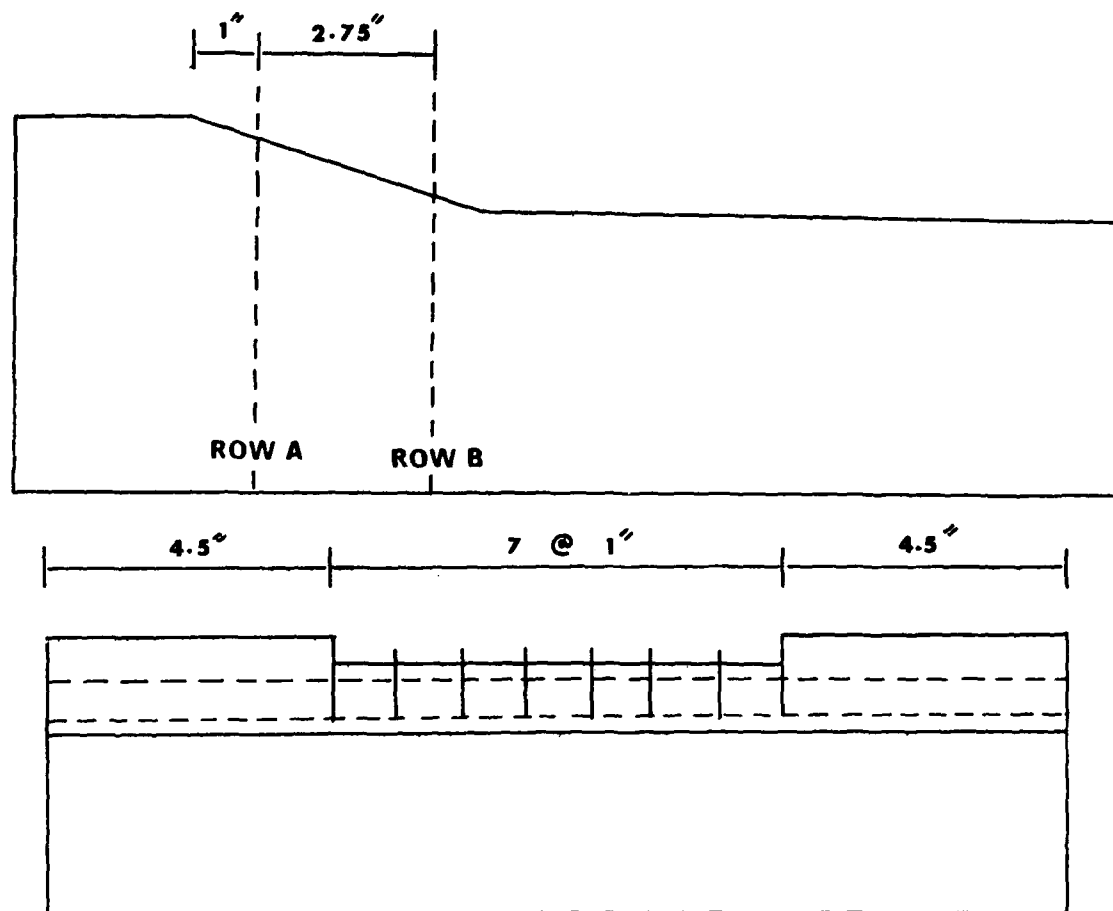
Figure 22 Manual measurement points for SLA embankment model.

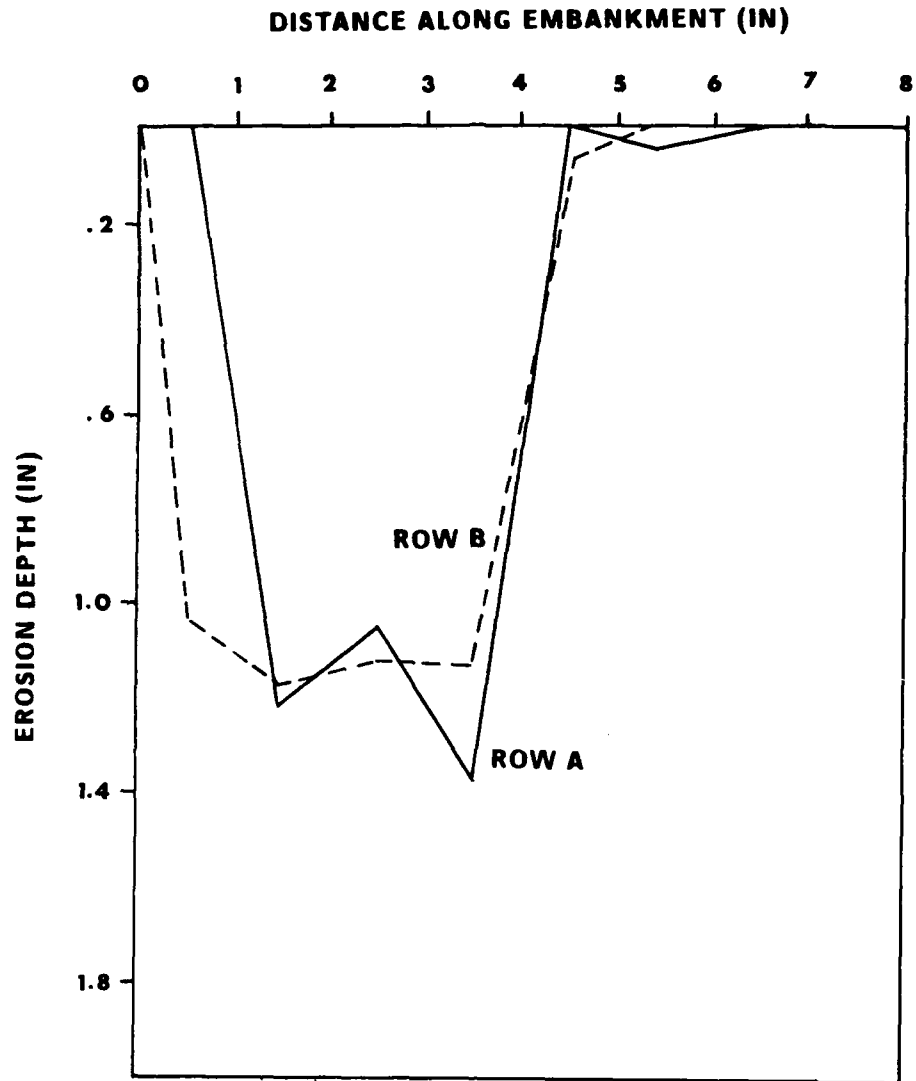
Figure 23 Erosion cross sections for SLA embankment model. (test 1).

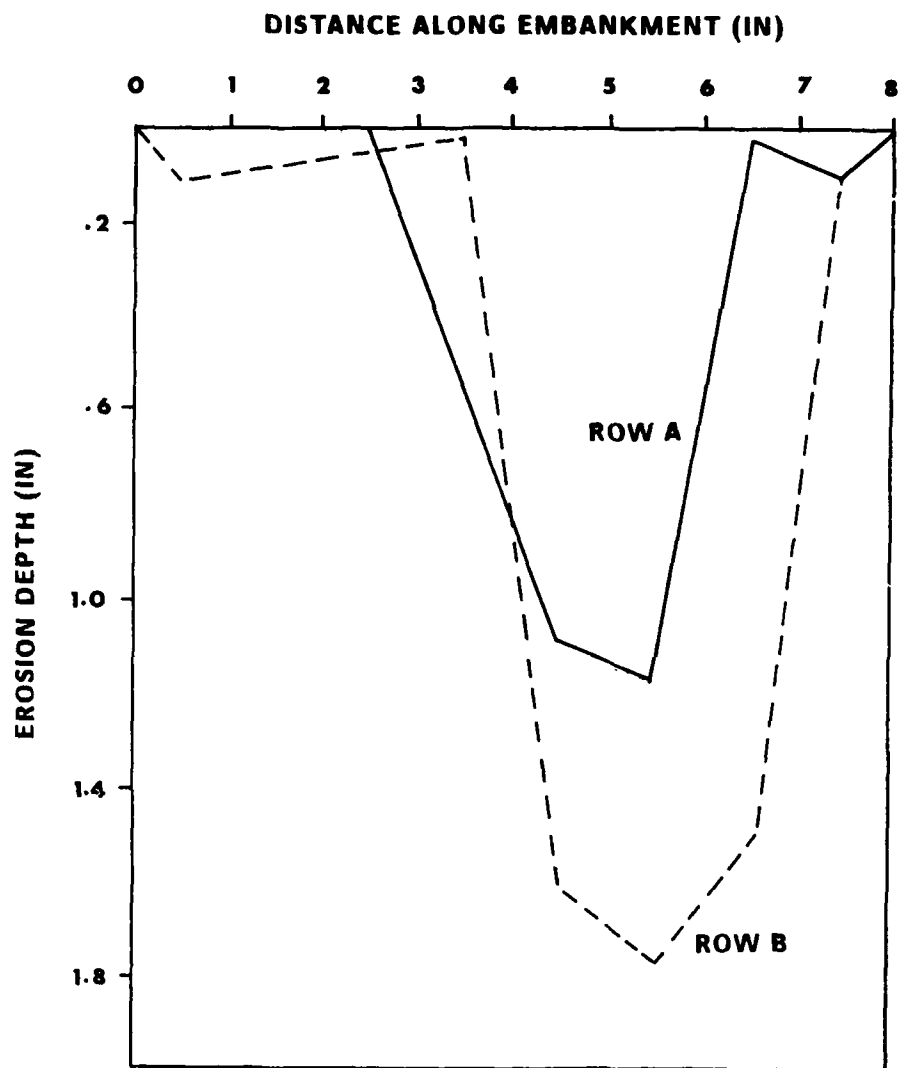
Figure 24 Erosion cross sections for SLA embankment model. (test 2).
